Black pus from a worn-out elbow arthroplasty

1 Clinical picture

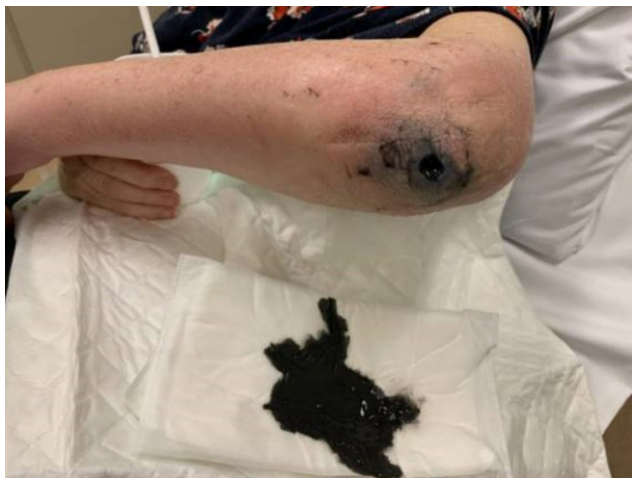
Figure 1. Draining sinus with black pus.

A 64-year-old woman with a medical history of rheumatoid arthritis and multiple joint prostheses presented to our hospital. She had been experiencing pain and a greyish swelling in her left elbow, which had undergone arthroplasty 25 years prior. The swelling eventually opened and drained black metal-like pus (Fig. 1). The prosthesis (a Kudo type 15) was extracted in a two-stage exchange procedure in which dark-grey debris and necrosis were observed (Fig. 2). Cultures revealed the presence of a polymicrobial periprosthetic joint infection (PJI). The patient was treated with amoxicillin and clavulanic acid for 6 weeks and had a flail elbow for 1 year. Finally she received a successful revision arthroplasty with a Coonrad-Morrey elbow prosthesis.

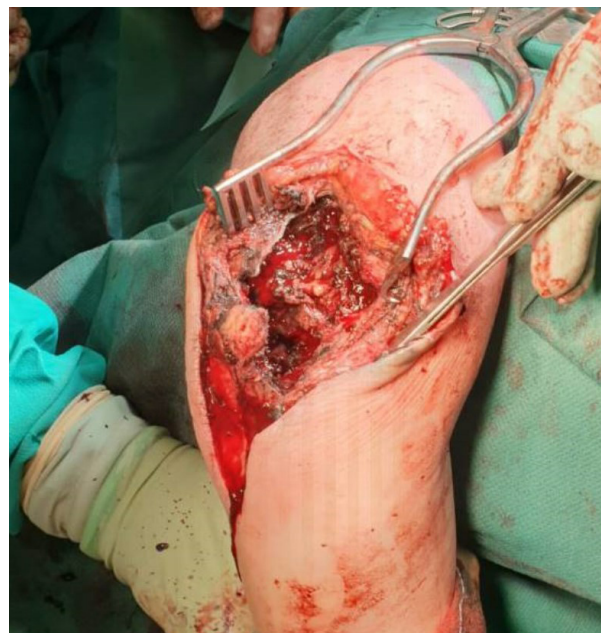
Figure 2. Grey-coloured synovitis and necrosis caused by metallic wear debris due to the release of cobalt, chromium, and titanium particles (Brinkman et al., 2007).

A worn-out elbow prosthesis causes polyethylene wear and, eventually, severe metallosis when not revised in a timely manner. Damage to the joint, surrounding bone, and soft tissue results in an impaired local immunity and sinus to the skin. These factors make the prosthetic joint more prone to subsequent polymicrobial infection (Barba et al., 2015; Tai et al., 2021).
